Durham E-Theses

A Prosim Knee Simulator Study of UHMWPE Wear: The Effect of Molecular Architecture and New Generation Radiation Crosslinking

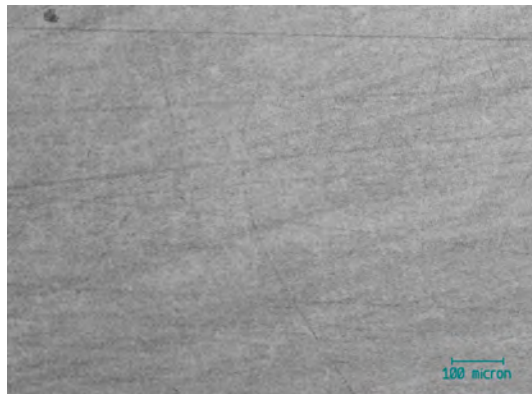
(a) 9,000,000 g/mol UHMWPE plate at location 2 after 0.5 MC. Note the smooth, burnished like appearance.

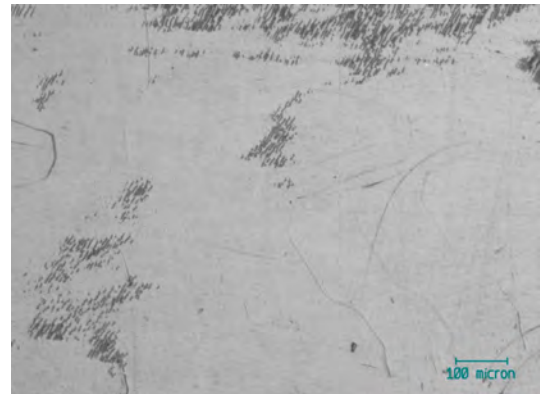
(b) 5,000,000 g/mol UHMWPE plate 3 at location 3 after 0.5 MC. Note the burnishing with sporadic areas of rippling.

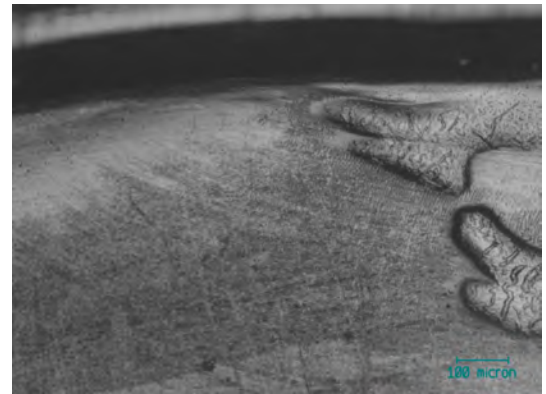
(d) 9,000,000 g/mol UHMWPE plate 3 at location 6 after 2.0×10^6 cycles. Note the material deposit at the wear track end.

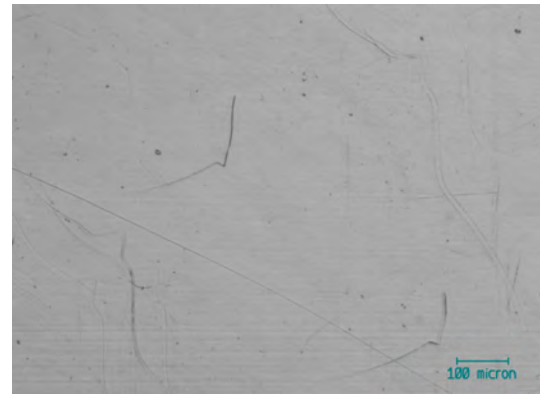
(b) Optical micrograph of plate A1 at location 4 after 0.5 MC. Note the burnished appearance of the plate.

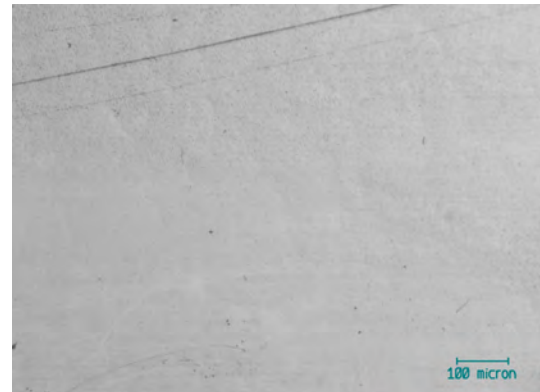
(b) Plate D8 at location 2 after 1.5 MC. Note the burnished appearance of the whole surface.

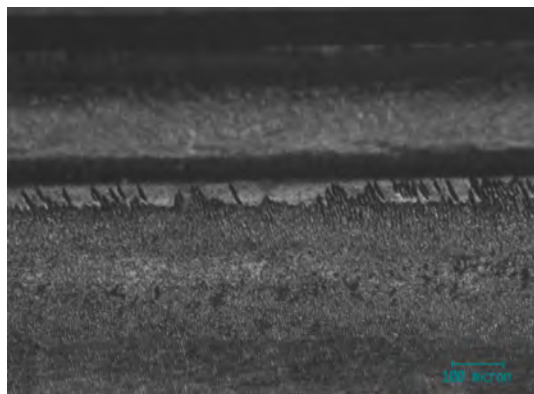
(a) Plate A8 at location 4 after 1.00 MC. Note the large ripples at the edge of the wear track, with smaller ripples towards the centre.

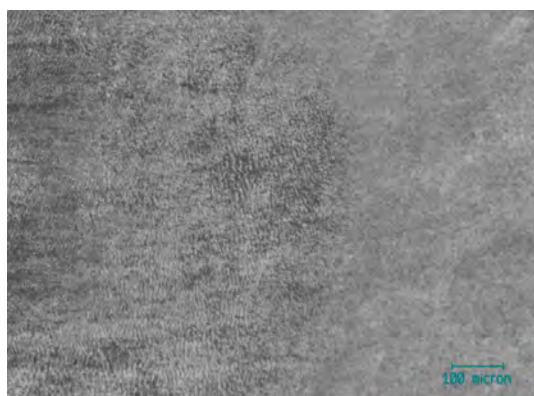
(c) Plate D5 at location 5 after 1.00 MC. Note that ripples stop where there would be no translation, only rotation.

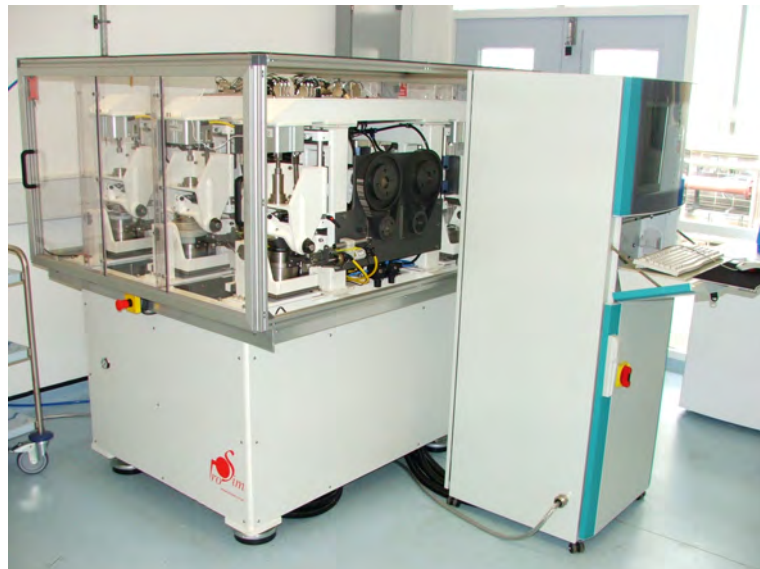
Figure 4.2: The six station ProSim knee wear simulator.

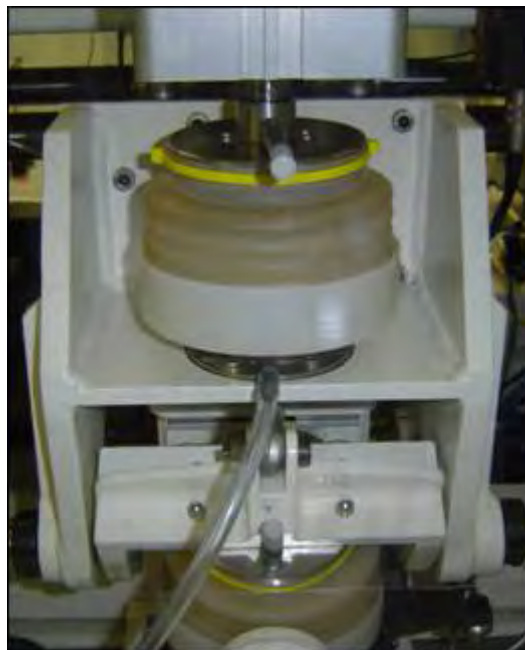
Figure 4.6: The load control station with gaiter *in situ*.

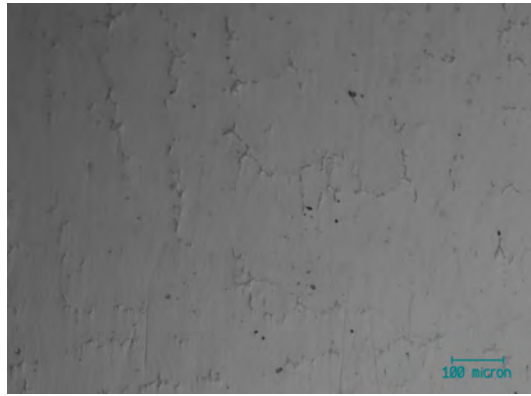
(a) Optical micrograph of Femur 7. This was contacting with the LSC and no surface damage is visible.

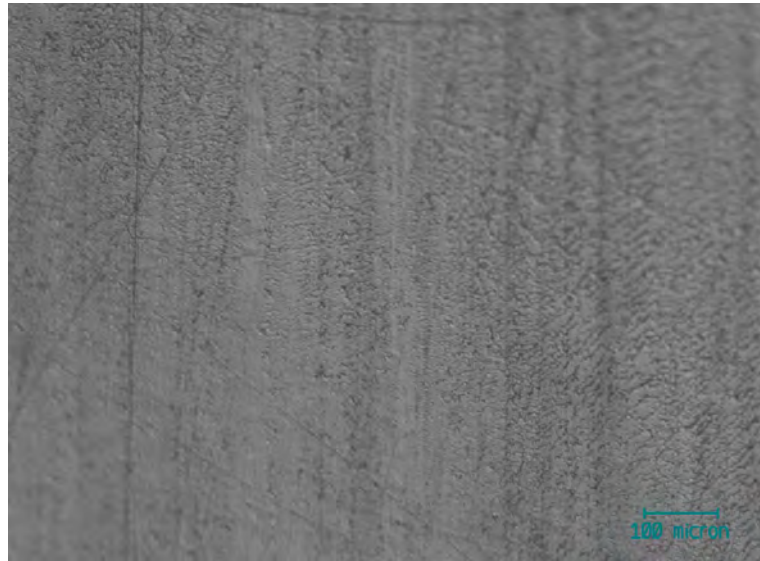
Figure 5.35: Clear example of rippling at location X5 Y21 at 0.1×10^6 cycles.

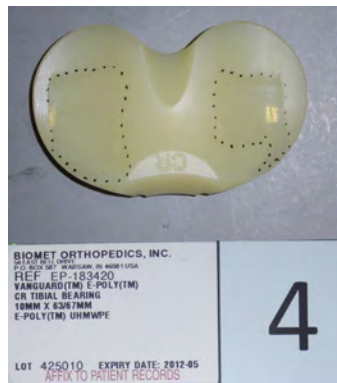
(d) Wear scar on E1™ tibia 4 after 2.5×10^6 cycles of testing.

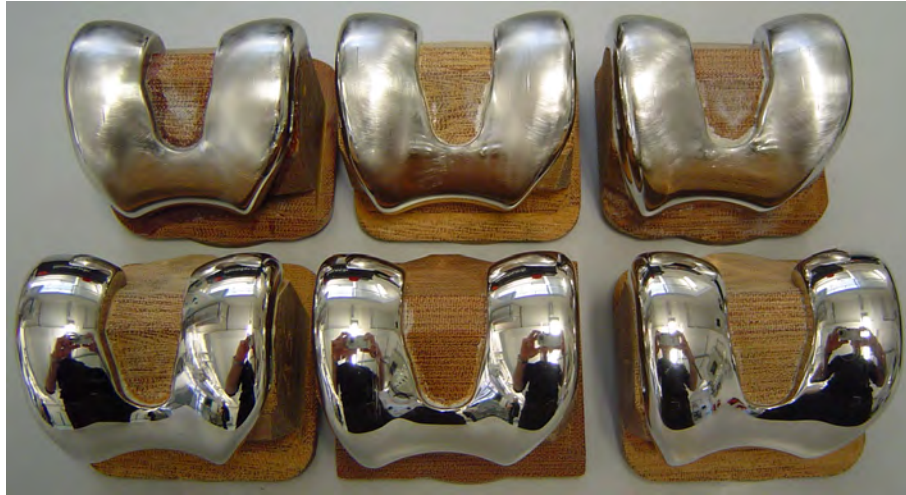
Figure 7.1: Photo showing artificially created scratches on femoral components (top) compared to femoral components after 11×10^6 cycles of wear testing (bottom).

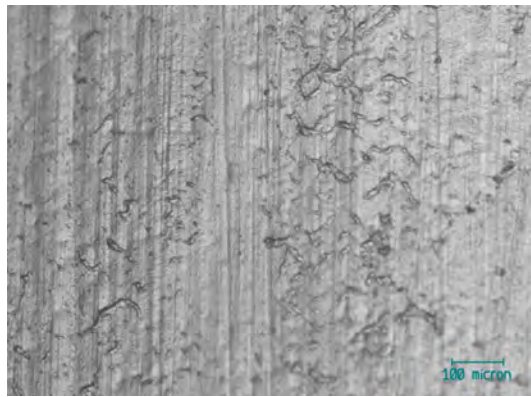
(c) E1[™] tibia 2 at location X8 Y15. Note the cracking perpendicular to the AP direction and scratching parallel to the AP direction.
